SEAT BELT WARNING LAMP FOR FRONT PASSENGER'S SEAT DOES NOT FLASH

INSPECTION PROCEDURE

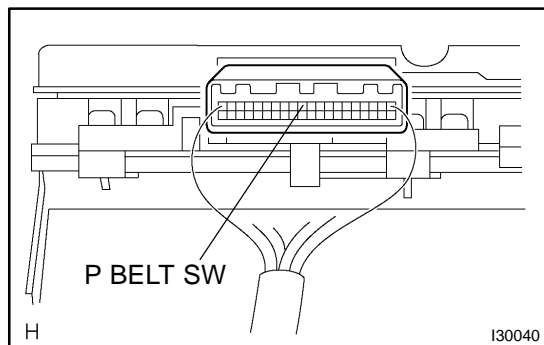
1 INSPECT COMBINATION METER ASSY

- (a) Ground terminal C9-11 on the combination meter side.
 (b) Check that the warning lightlights up.
OK: Warning light lights up.

OK**Go to step 3****NG****2 INSPECT PASSENGER SEAT BELT WARNING LAMP ASSY**

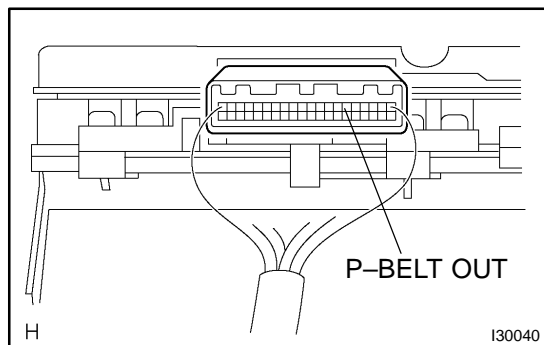
- (a) Ground terminal C9-6 on the combination meter side.
 (b) Check that the warning lightlights up.
OK: Warning light lights up.

NG**CHECK AND REPLACE PASSENGER SEAT BELT WARNING LAMP ASSY****OK****CHECK AND REPLACE COMBINATION METER ASSY****3 INSPECT FRONT SEAT INNER BELT ASSY RH**

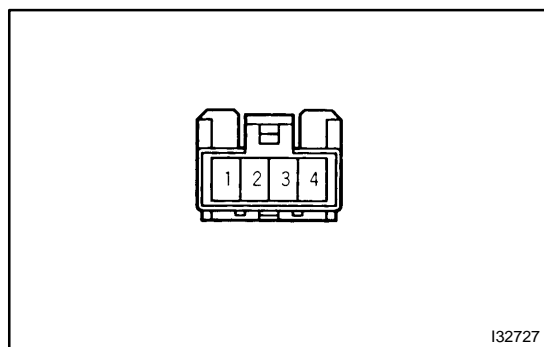
- (a) Check continuity.
 (1) Disconnect the front seat inner belt assy.
 (2) Check the continuity in between terminals 1 and 2 of front seat inner belt assy RH.

Condition	Continuity
Seat belt is fastened	Continuity
Seat belt is unfastened	No continuity

NG**CHECK AND REPLACE FRONT SEAT INNER BELT ASSY RH****OK**

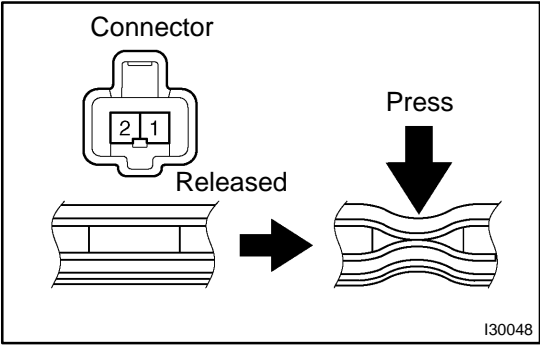
4 INSPECT SEPARATE SEAT TYPE FRONT SEAT CUSHION PAD

- (a) Disconnect the separate type front seat cushion pad.
- (b) Check continuity separate type front seat cushion pad.

Sear condition	Terminal	Specified condition
Released	1 – 2	No continuity
Pressed	1 – 2	Continuity

NG CHECK AND REPLACE SEPARATE SEAT TYPE FRONT SEAT CUSHION PAD
